National Public Adjusting

Insured: Cole & Ashcroft, L.P.
Business: 5631 Brystone Drive
Houston, TX 77041

Price List: TXHO8X_JUL19
Restoration/Service/Remodel
Estimate: COLE&ASHCROFT

**DEFENDANT'S
EXHIBIT F**

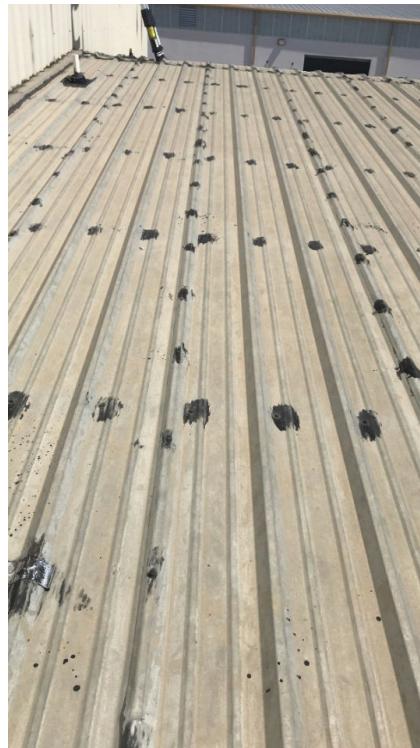
15 15-Lower Roof Over Offices

The only roof the engineer inspected and included in his report.

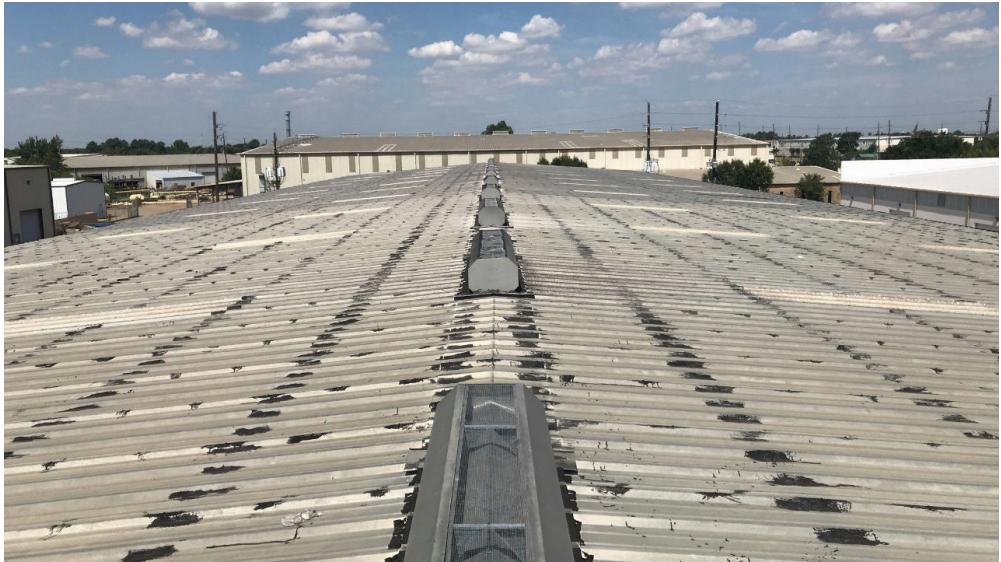
17 17-Warehouse Roof Overview

An overview of the 30,000 square foot roof that engineer Luis Ulloa from ProNet Group Inc failed to inspect or even make mention of in his report. Mr. Ulloa came out to inspect the loss location which consist of 33,691 square feet of roof covering. Of the 33,691 square feet, Mr. Ulloa only inspected 3,850 square feet and denied the entire claim based on his findings. Mr. Ulloa likely did not get on this portion of the roof because it would have required a ladder pull. He either didn't have another ladder with him or he didn't care enough about the insured to come back with a ladder to do the job he was hired to do.

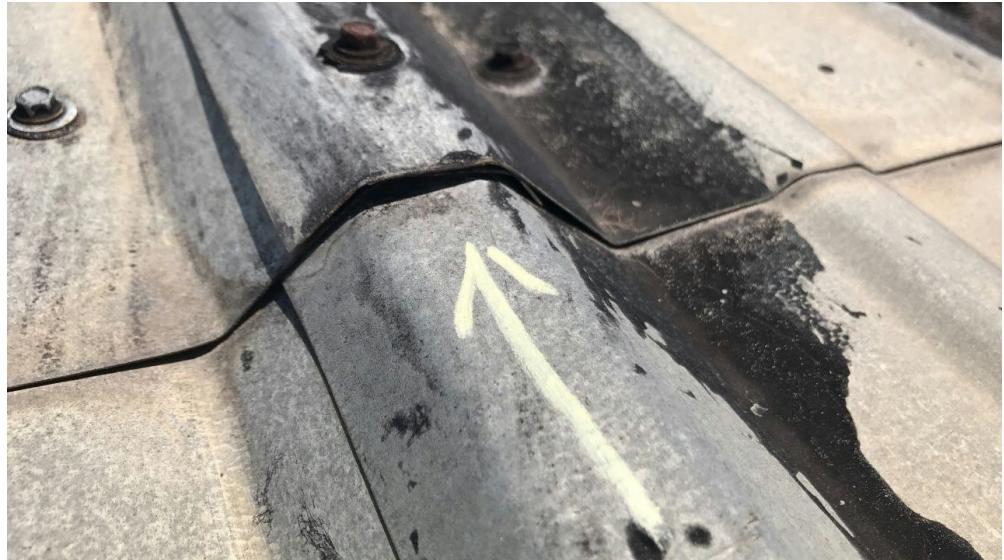
20 20-Wind Lifted Metal Panels

The high winds of Hurricane Harvey caused the metal panels to lift and in some cases bend. This picture illustrates the damage left behind, this roof panel no longer sits flush. It is now bent out of shape and is a vulnerable entry point for the elements.

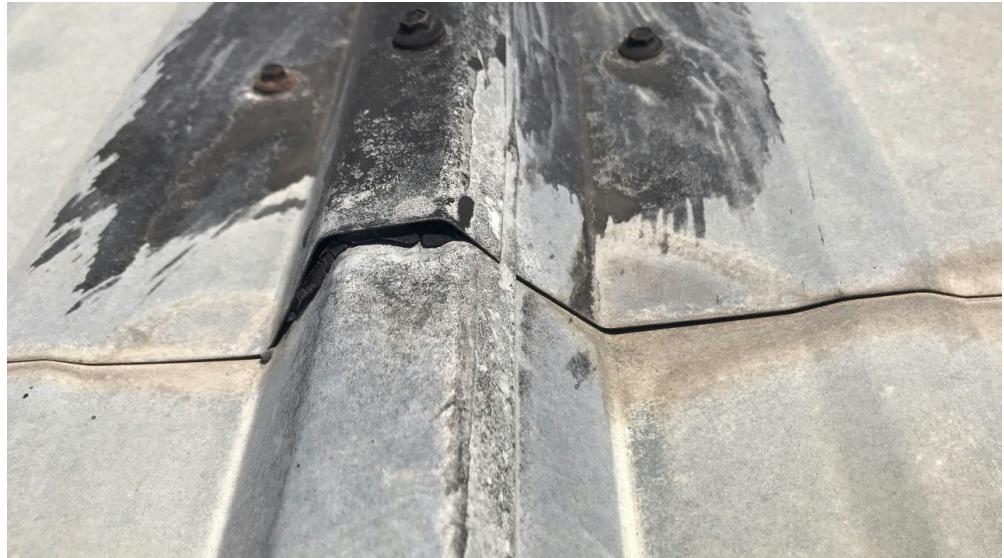
22 22-Wind Lifted Metal Panels

More evidence of the metal roof panels not sitting flush anylonger.

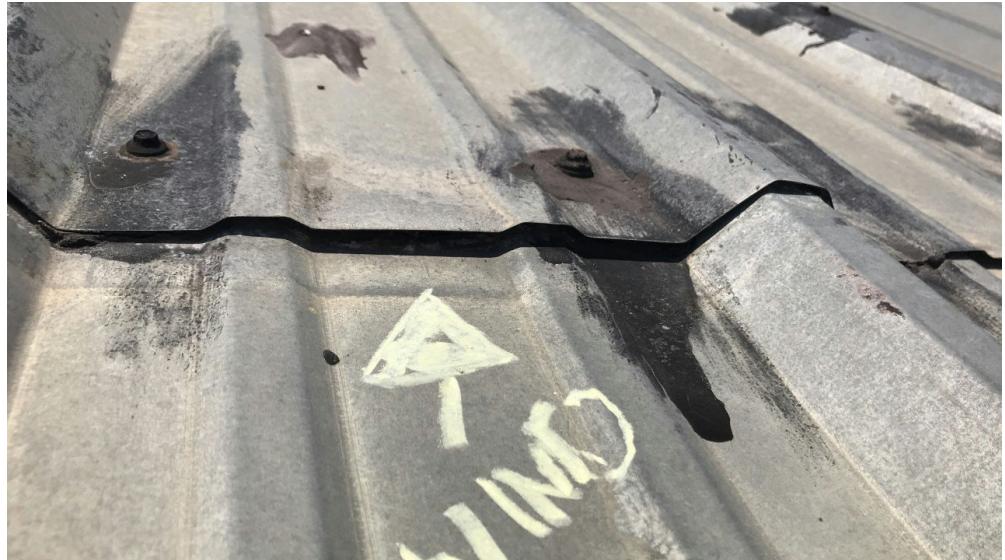
23 23-Metal Roof Panels Show Uplift From Wind

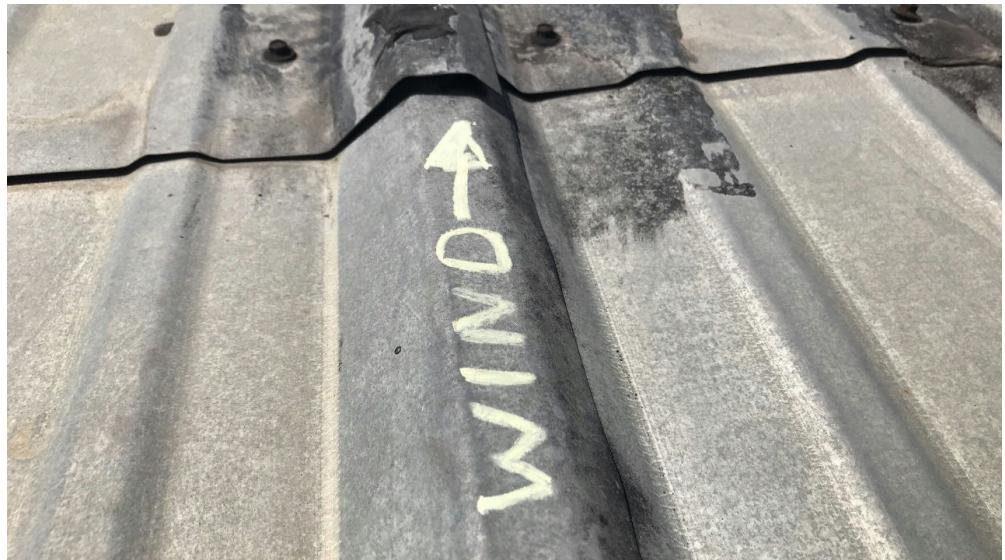
24 24-More Wind Lifted Roof Panels

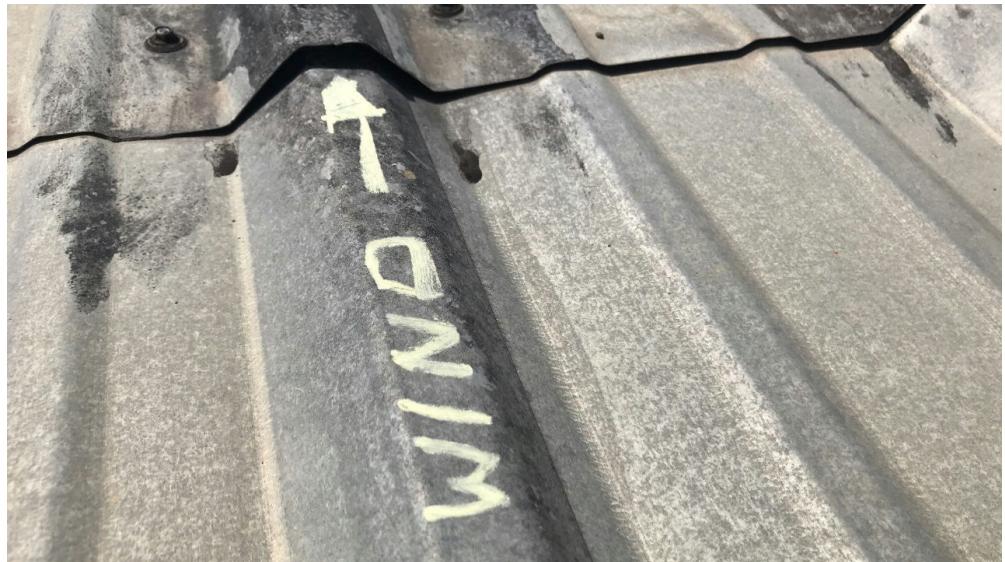
25 25-More Evidence Of Metal Panels Being Bent Out Of Shape And Not Sitting Flush Anymore

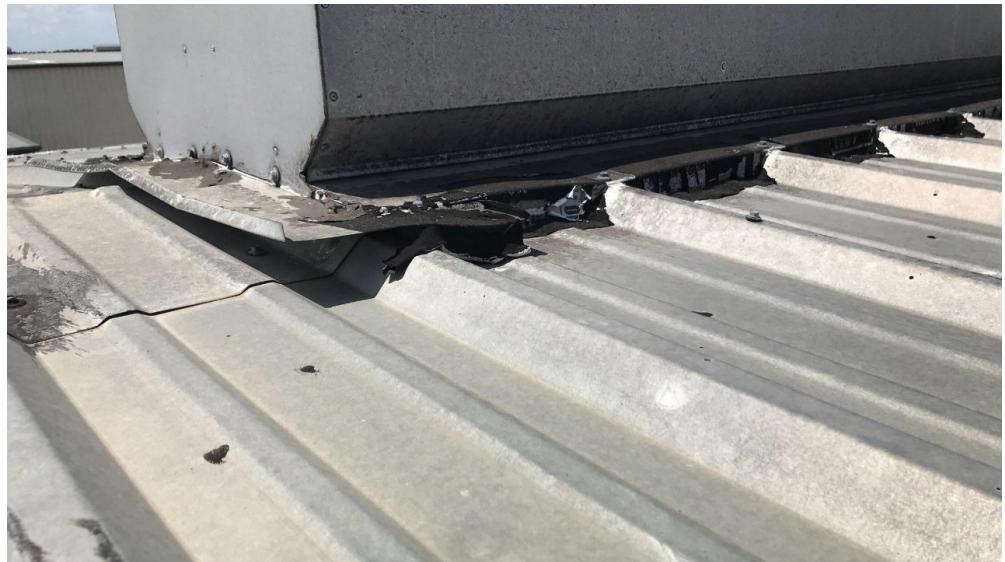
26 26-Notice The Ridge Vent Flashing Is Bent Up Wards

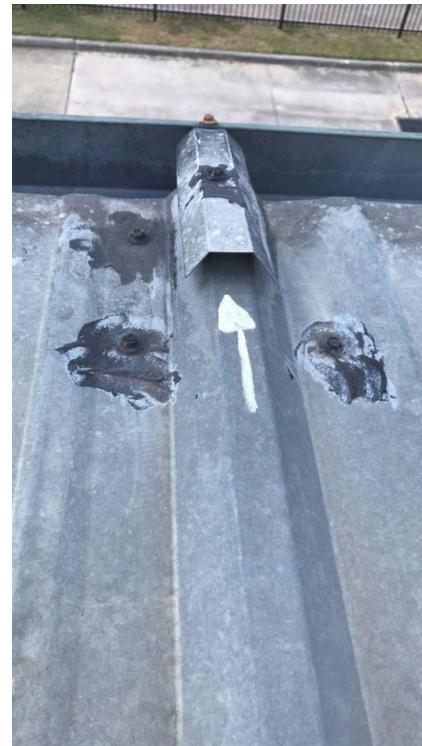
The gutters were not designed to hold the amount of water that Hurricane Harvey dumped. The weight of being full of water for 3 days caused the gutters to sag and has bent the brackets that holds them in place. This has also damaged the roof panels that the brackets are mounted to.

28 28-Gutter Bracket Is Permanently Bent And Does Not Sit Flush

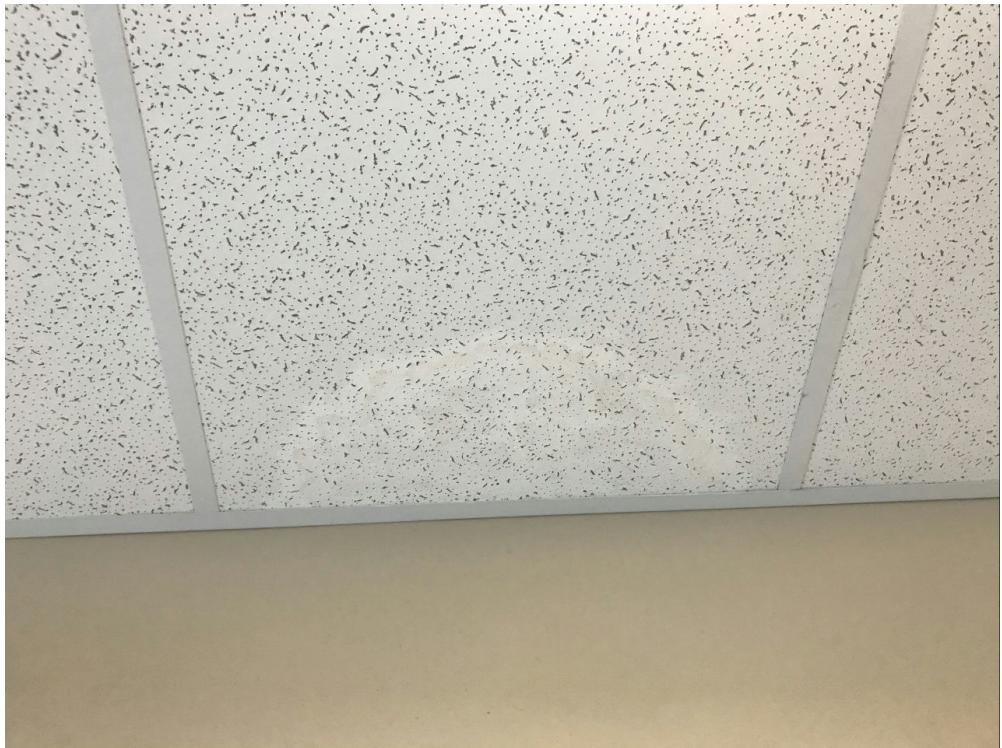
32 32-Lobby Ceiling Tile Has Water Stain

This photo clearly illustrates that water has stained the ceiling tile and has also made contact with the metal ceiling grid.

29. Clean suspended ceiling grid	94.88 SF	0.28	0.00	5.32	31.89	(0.00)	31.89
Clean suspended ceiling tile grid to ensure rust does not form. This is a reasonable alternative line item to salvage the existing grid that has been exposed to water damage.

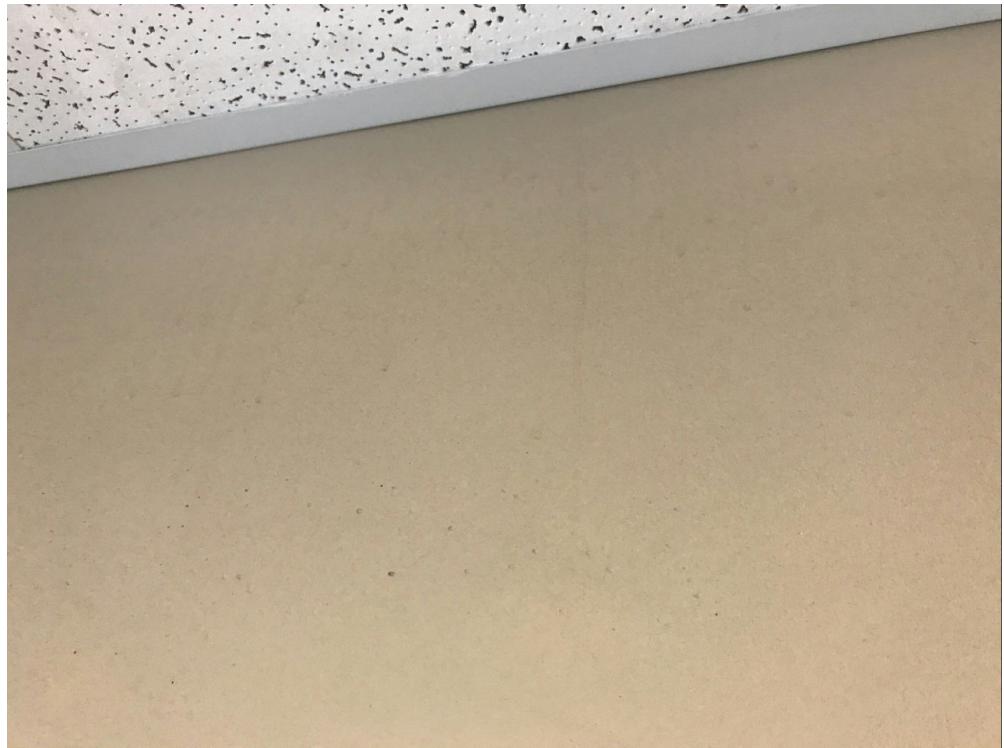
34 34-Lobby Walls Have Water Streaks

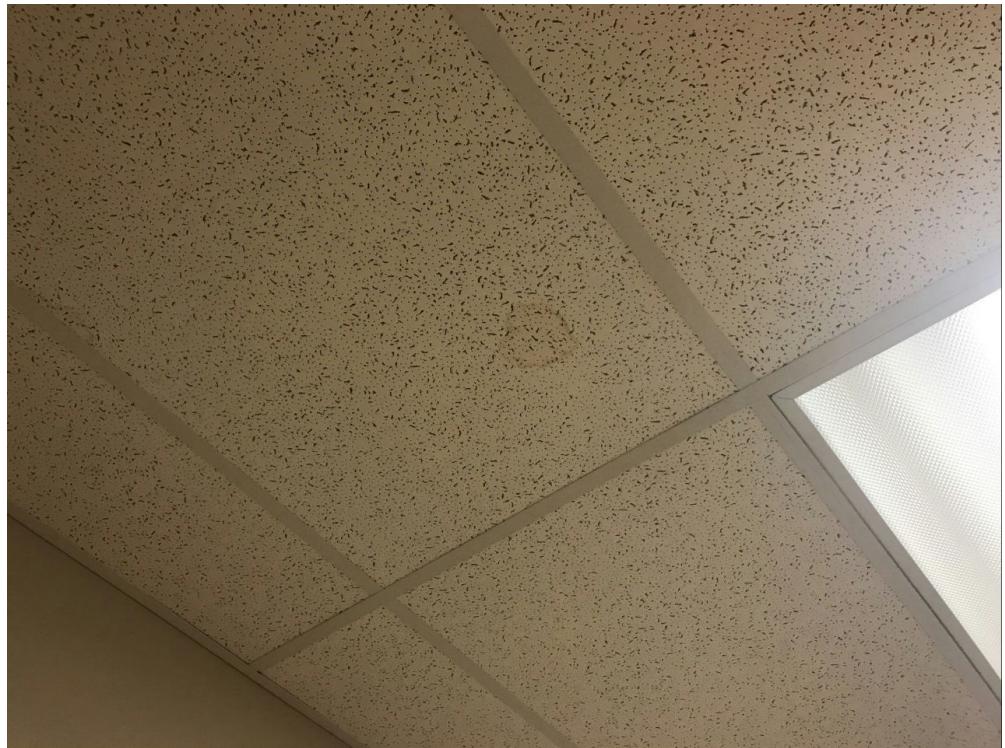
46 46-Cubicle Room/Reception Water Stained Ceiling Tiles

Many ceiling tiles have been repeatedly replaced since Hurricane Harvey.

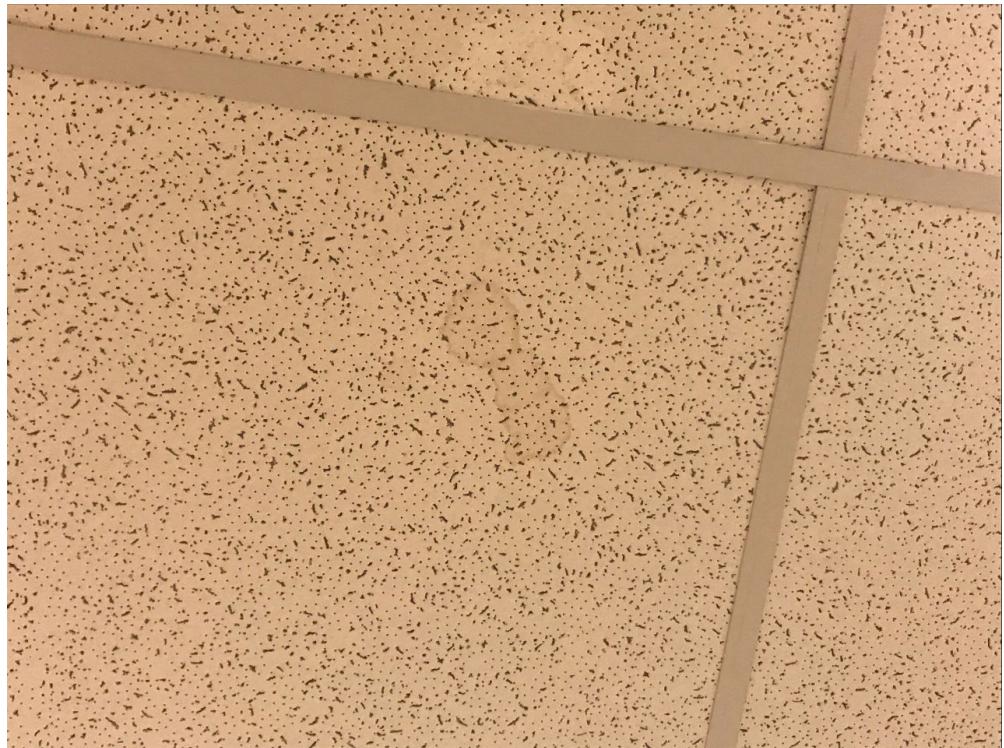
47 47-Cubicle Room/Reception Water Stained Ceiling Tiles

Many ceiling tiles have been repeatedly replaced since Hurricane Harvey.

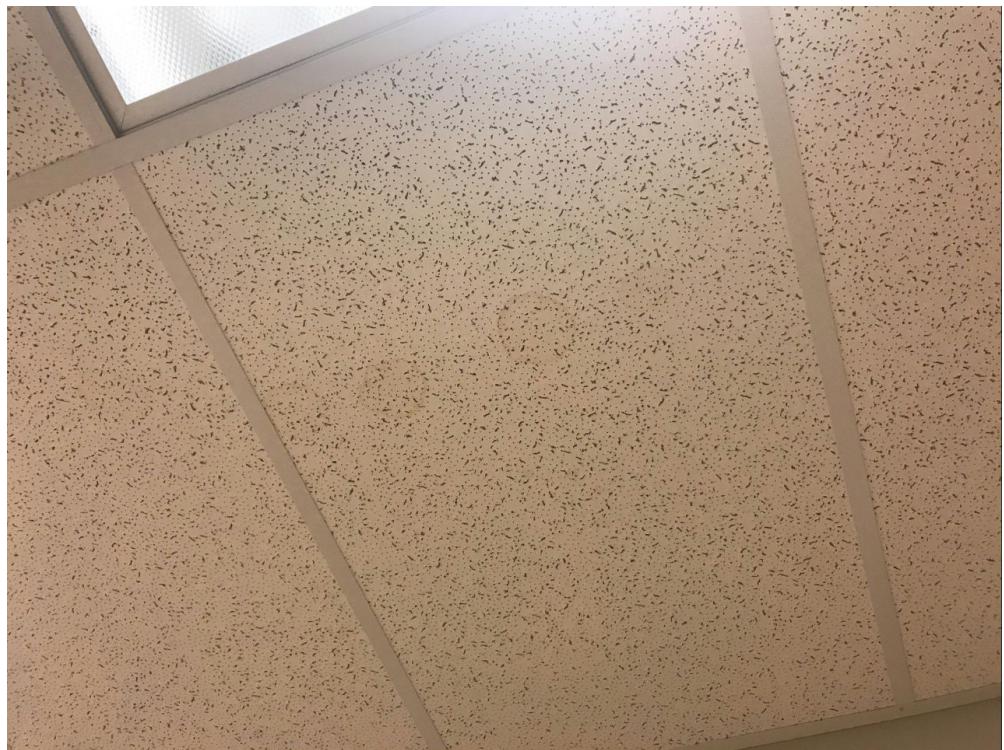
48 48-Cubicle Room/Reception Water Stained Ceiling Tiles

Many ceiling tiles have been repeatedly replaced since Hurricane Harvey.

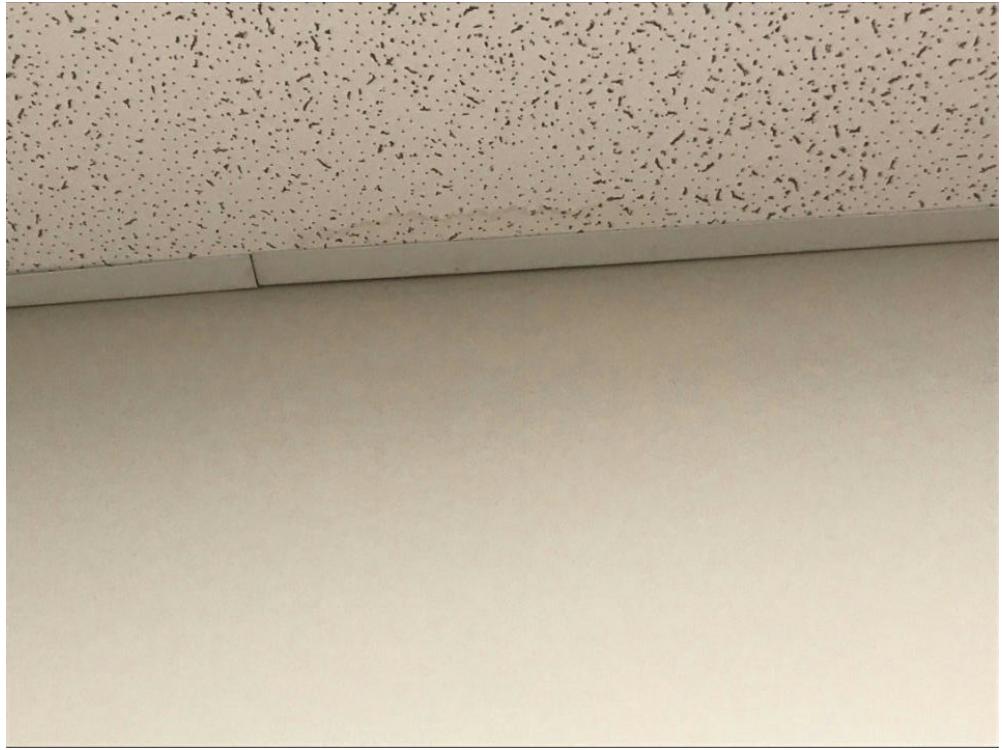
49 49-Cubicle Room/Reception Water Stained Ceiling Tiles

Many ceiling tiles have been repeatedly replaced since Hurricane Harvey.

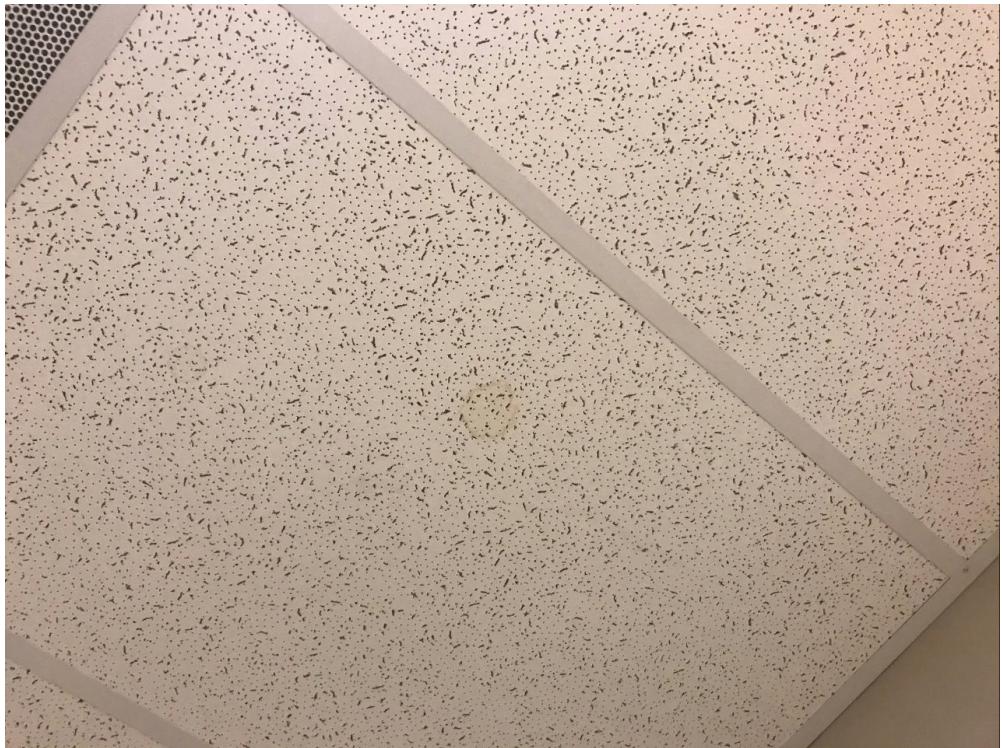
50 50-Cubicle Room/Reception Water Stained Ceiling Tiles

Many ceiling tiles have been repeatedly replaced since Hurricane Harvey.

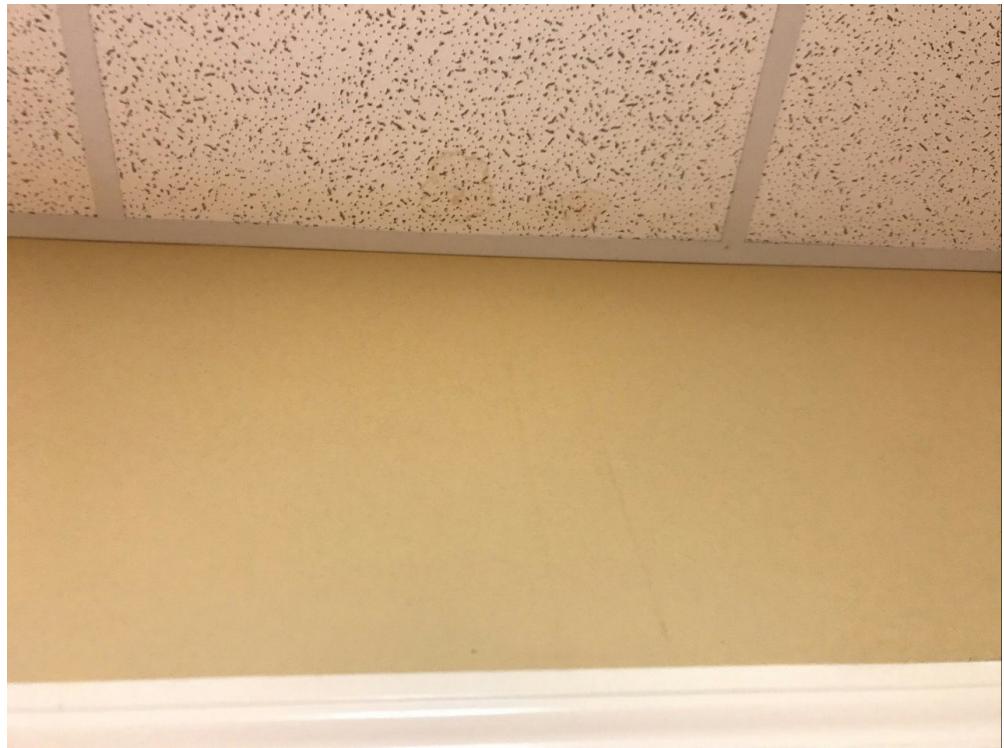
57 57-Office Ceiling Overview

This photo illustrates water stained ceiling tiles and also depicts water stains on the drywall.

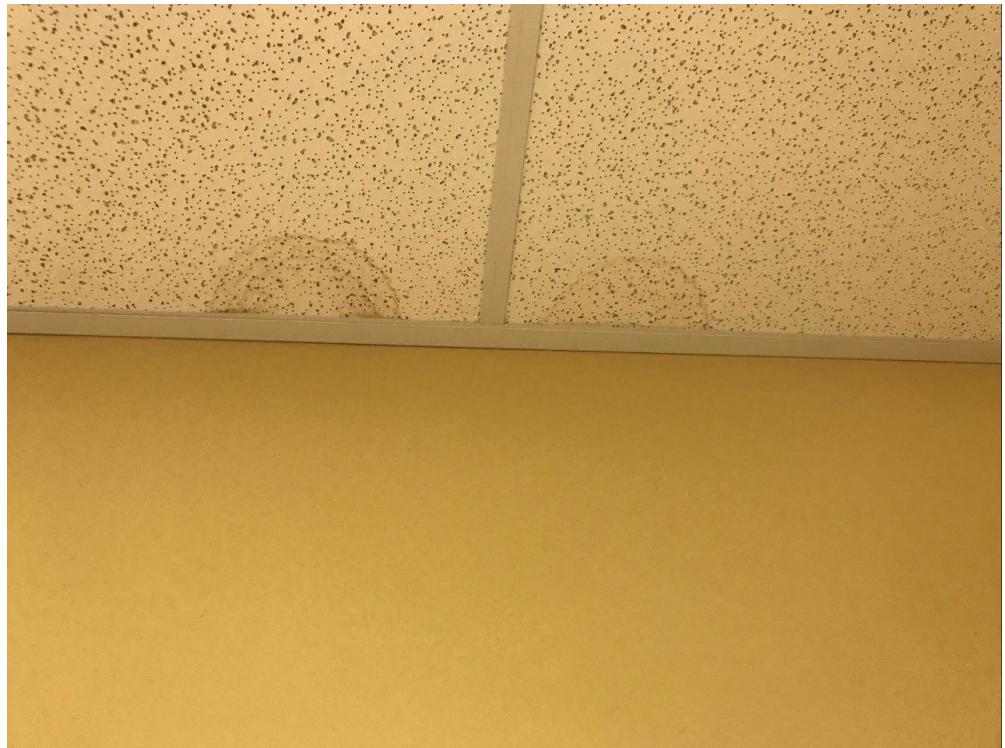
68 68-Conference Room Ceiling

This photo illustrates water stained ceiling tiles having made contact with the metal ceiling tile grid.

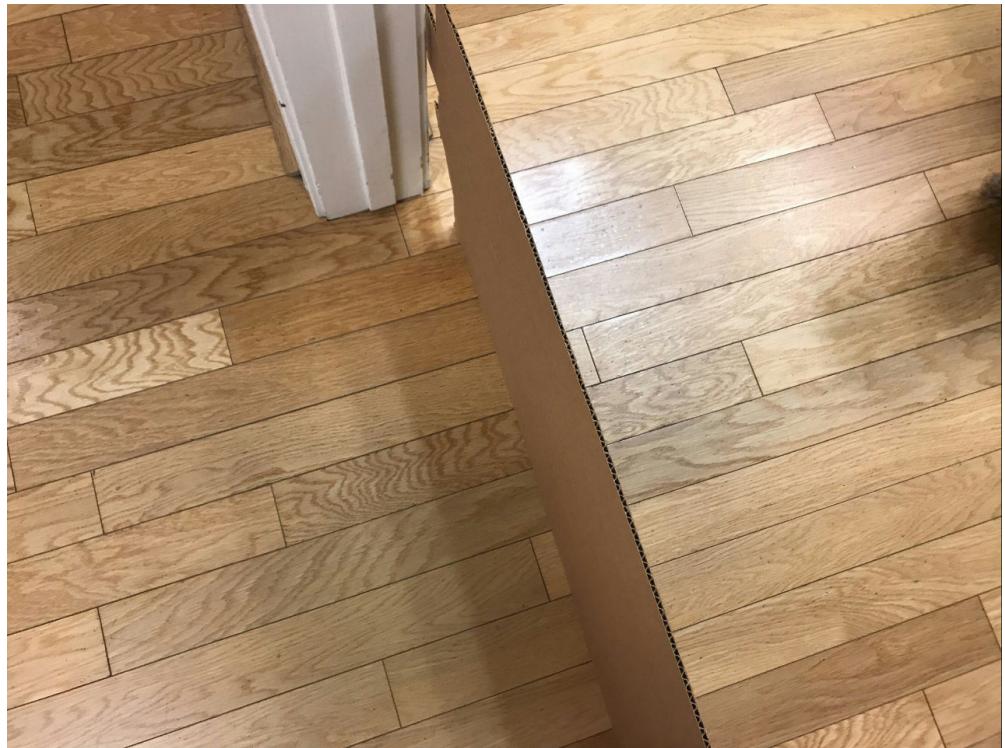
76 76-Office 6 Floors Continuous

The cardboard box in the photo has nothing to do with the claim. The employees had boxes on the floor. This photo illustrates the continuous flooring throughout the office.

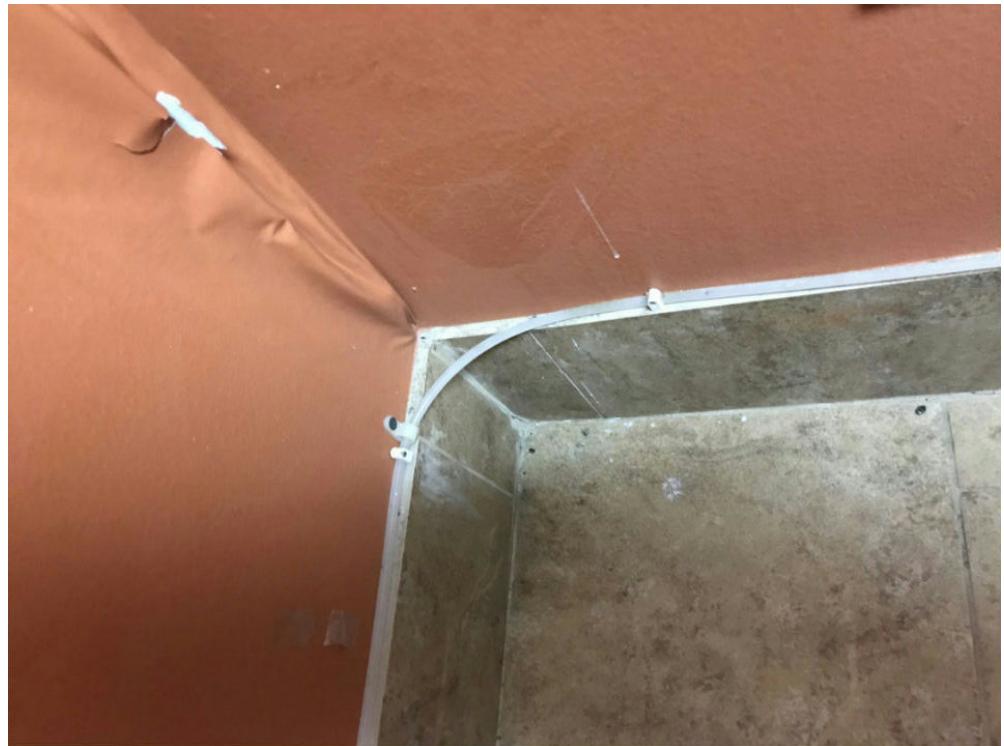
90 90-Kitchen Water Damaged Drywall

This photo illustrates the need to remove and replace the water damaged drywall. In doing so the tile perimeter trim will also need to be removed. Removing the tile will result in breaking the tiles and the surrounding tiles.

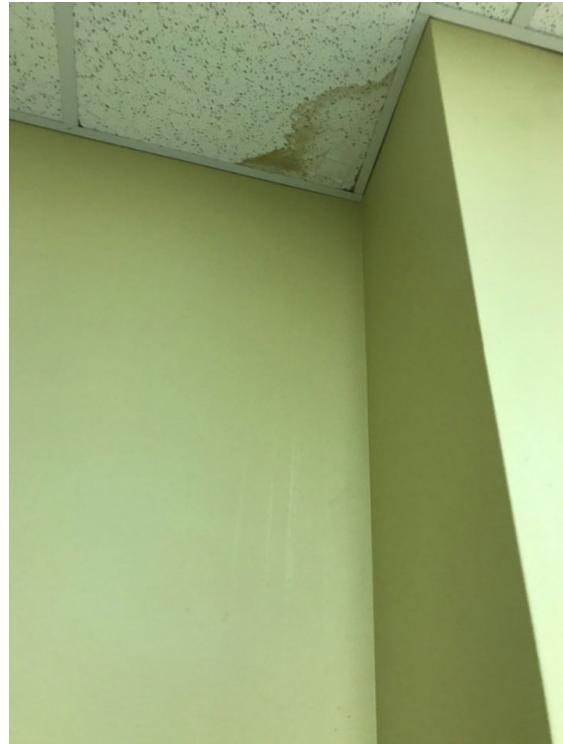
100 100-Studio Ceiling

This photo illustrates the water damage to the ceiling and the 1/2" drywall on the walls.

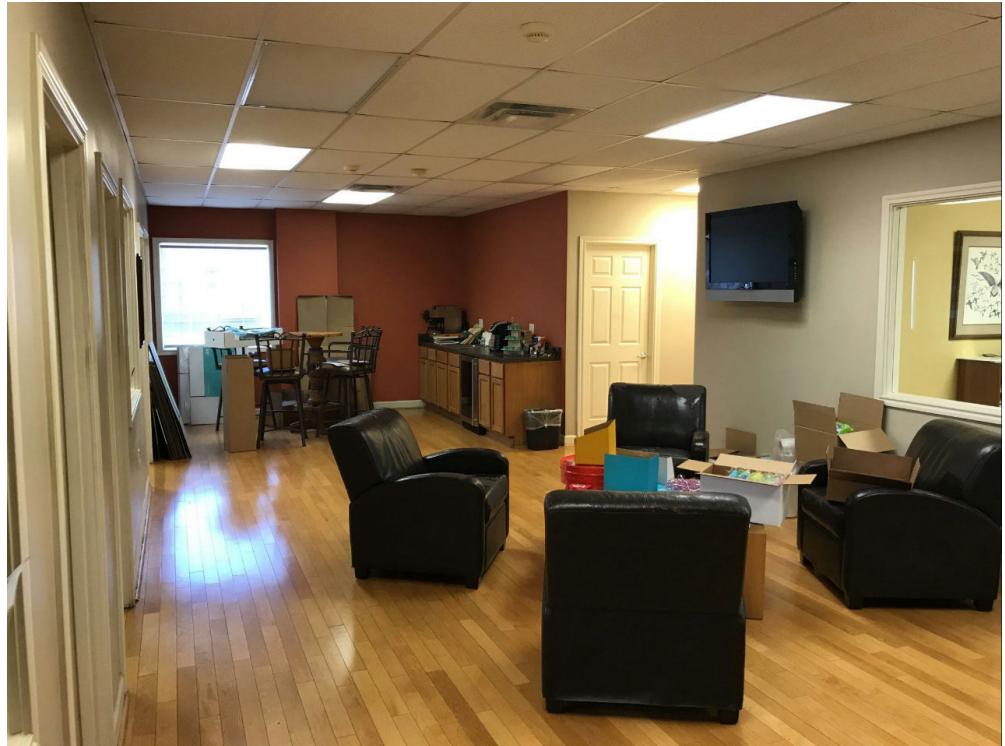
Notice that the wood floors are continuous.

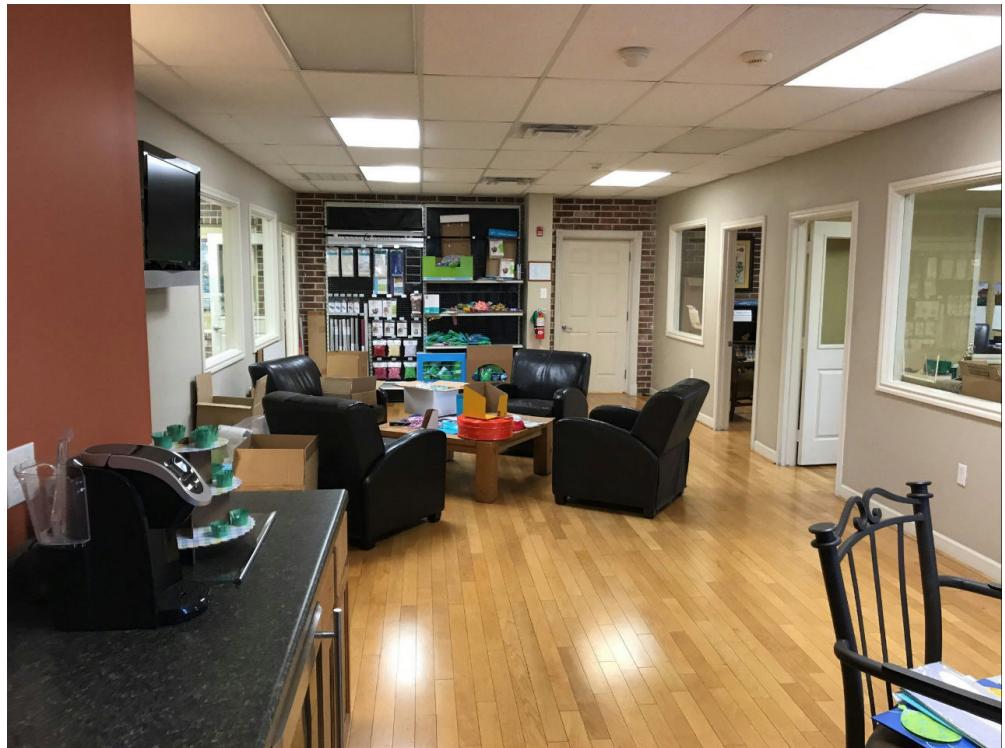
104 104-Lounge Room Overview

Notice that the wood floors are continuous.

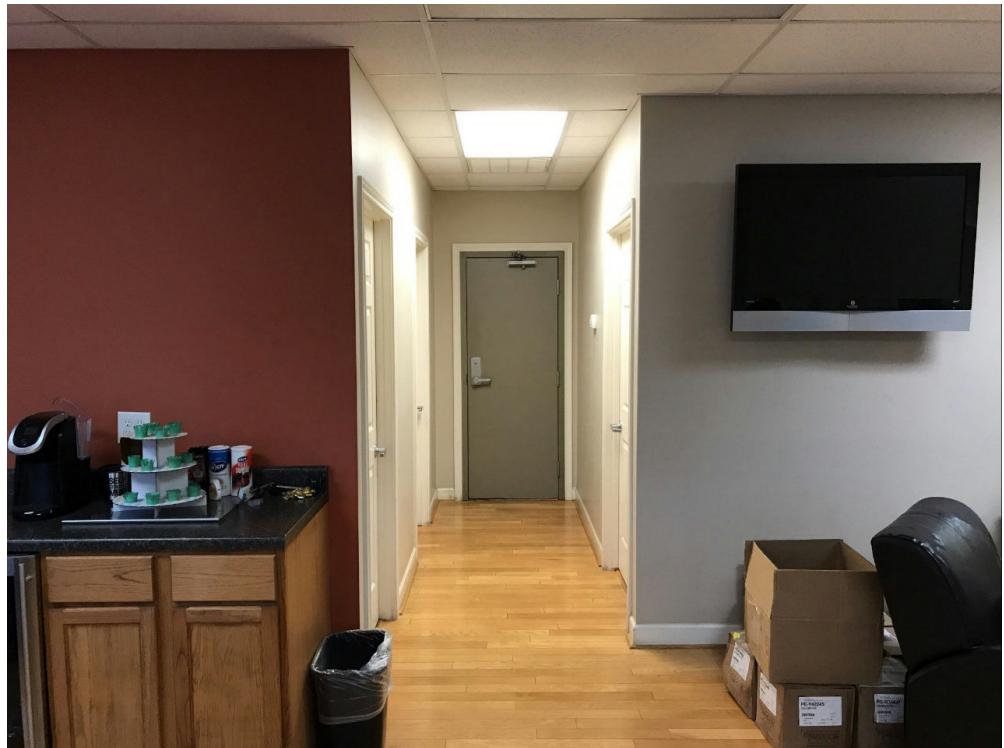
Notice that the wood floors are continuous.

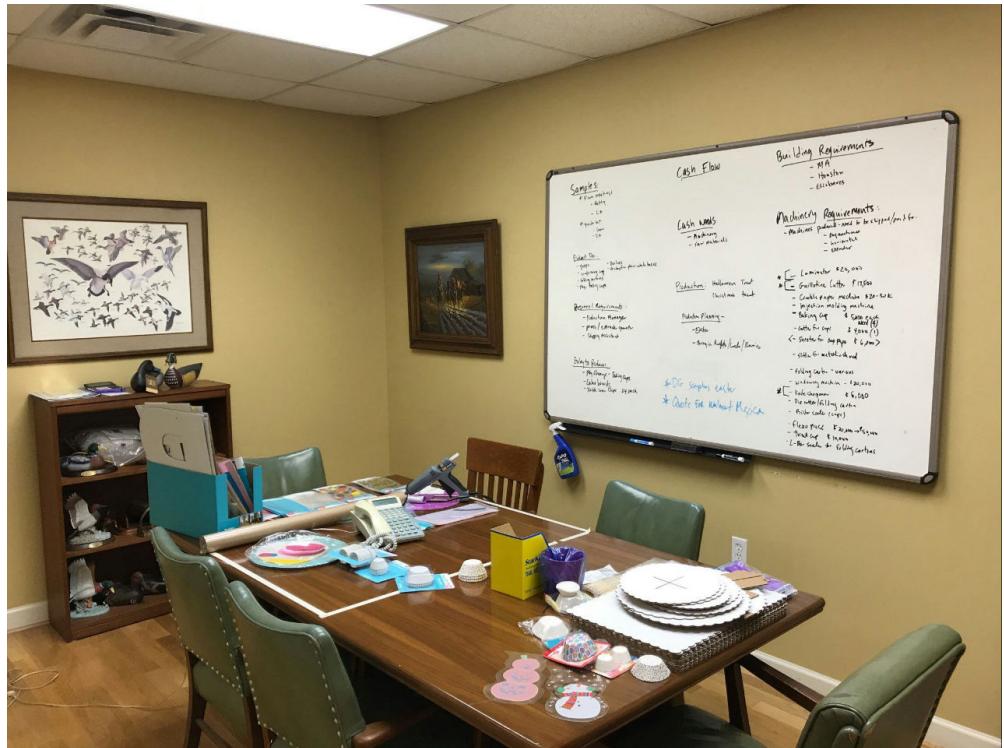
107 107-Conference Room #2
Overview
Date Taken: 8/6/2019

Notice that the wood floors are continuous.

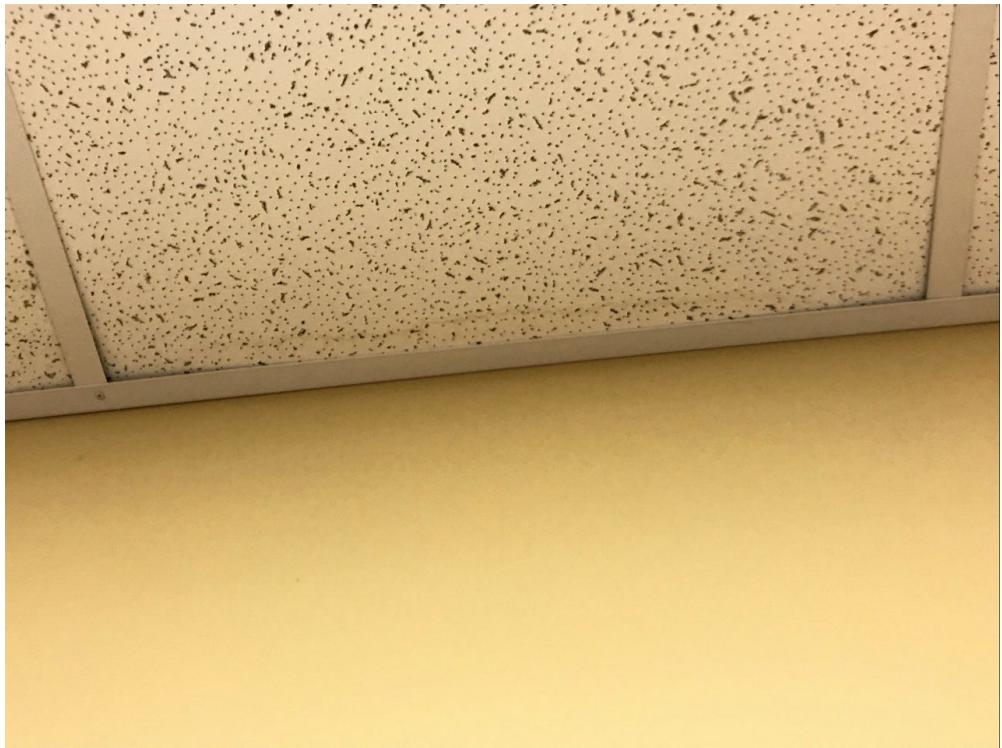
Notice that the water stains are right
on and over the metal ceiling tile grid.

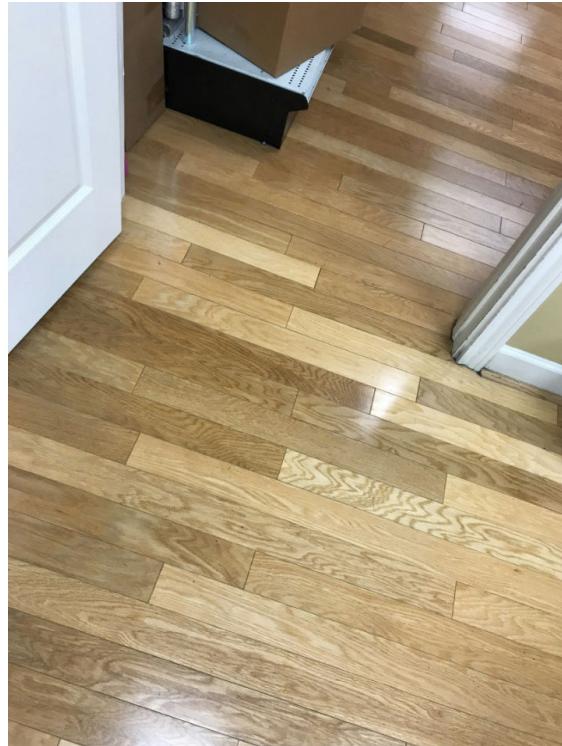
Notice that the wood floors are continuous.

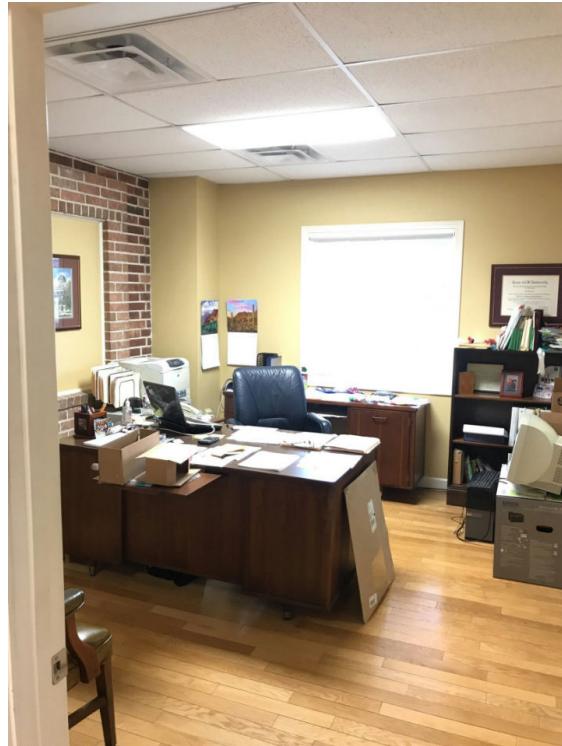
114 114-Office 3 Overview

Notice that the wood floors are continuous.

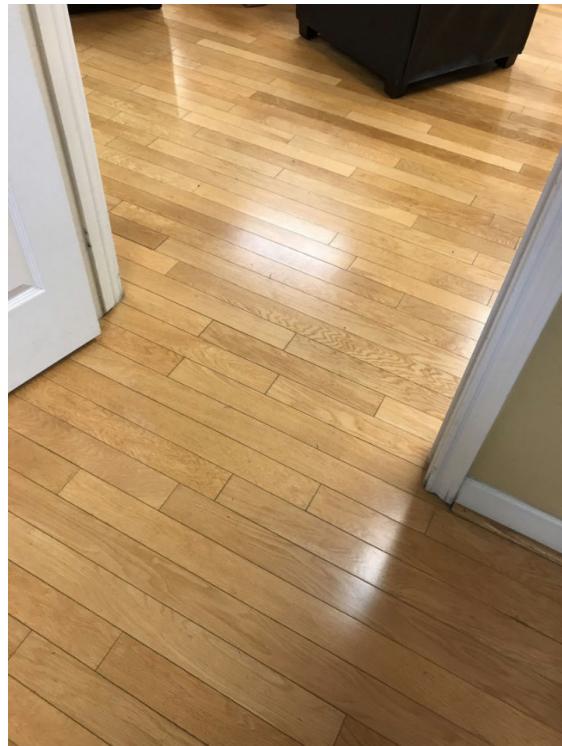
117 117-Office 3 Wood Floor Is
Continuous
Date Taken: 8/6/2019

Notice that the wood floors are
continuous.

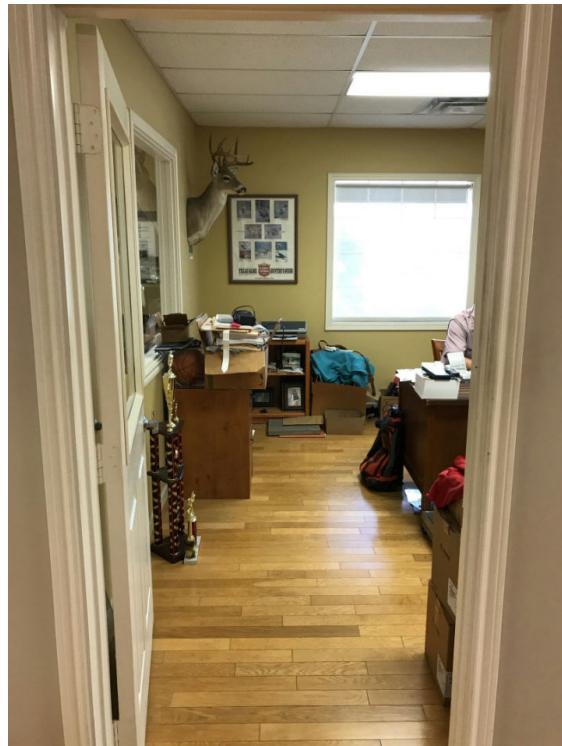
118 118-Office 2 Overview
Date Taken: 8/6/2019

Notice that the wood floors are
continuous.

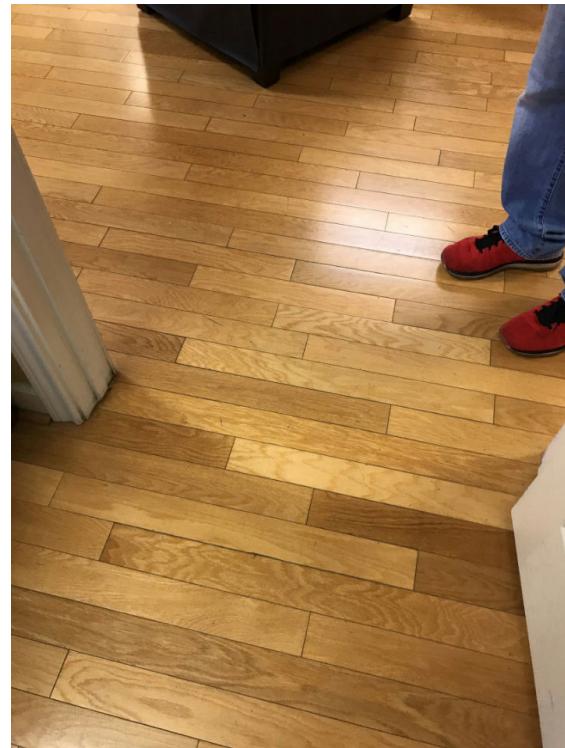
120 120-Office 2 Floors

Notice that the wood floors are continuous.

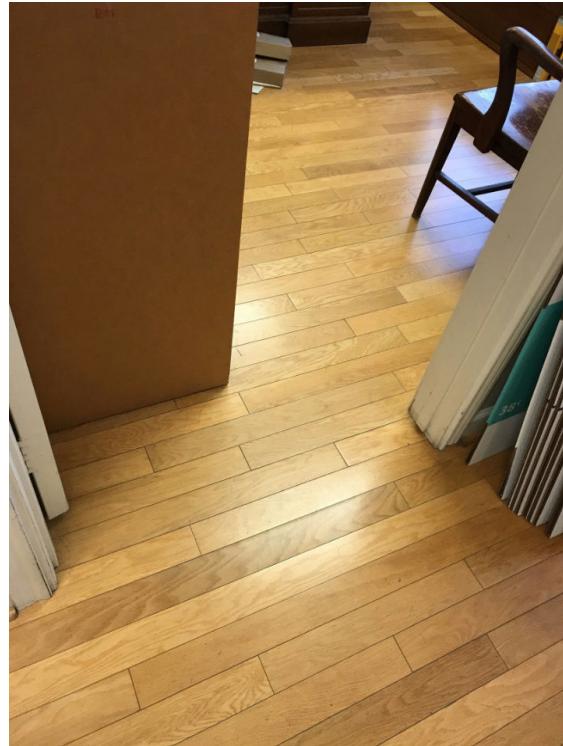
Notice that the wood floors are continuous.

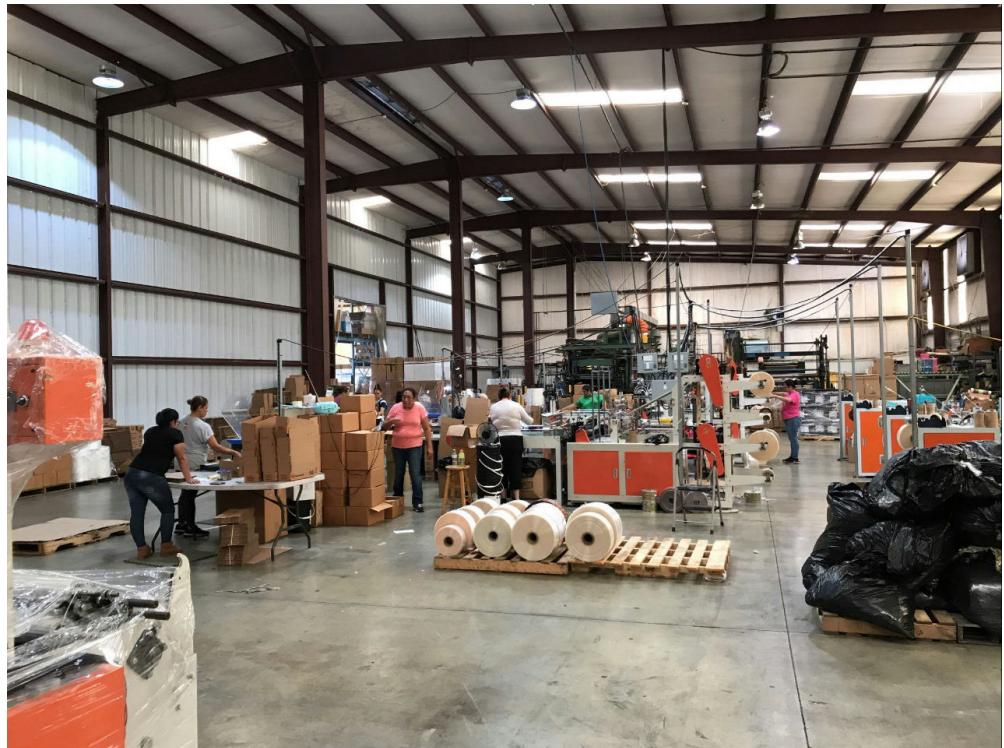
127 127-Warehouse Equipment Overview
Date Taken: 8/6/2019

There are 20 employees that work in the warehouse.

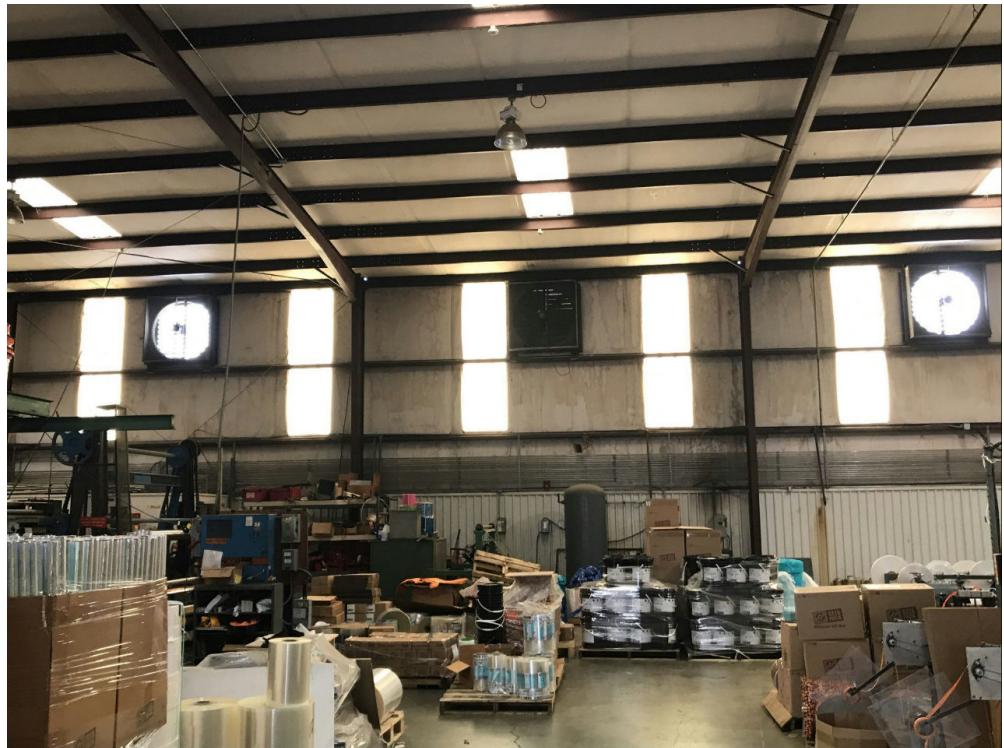
This photo shows a failed warehouse vent that stopped working after Hurricane Harvey. This line item is in the Warehouse folder.

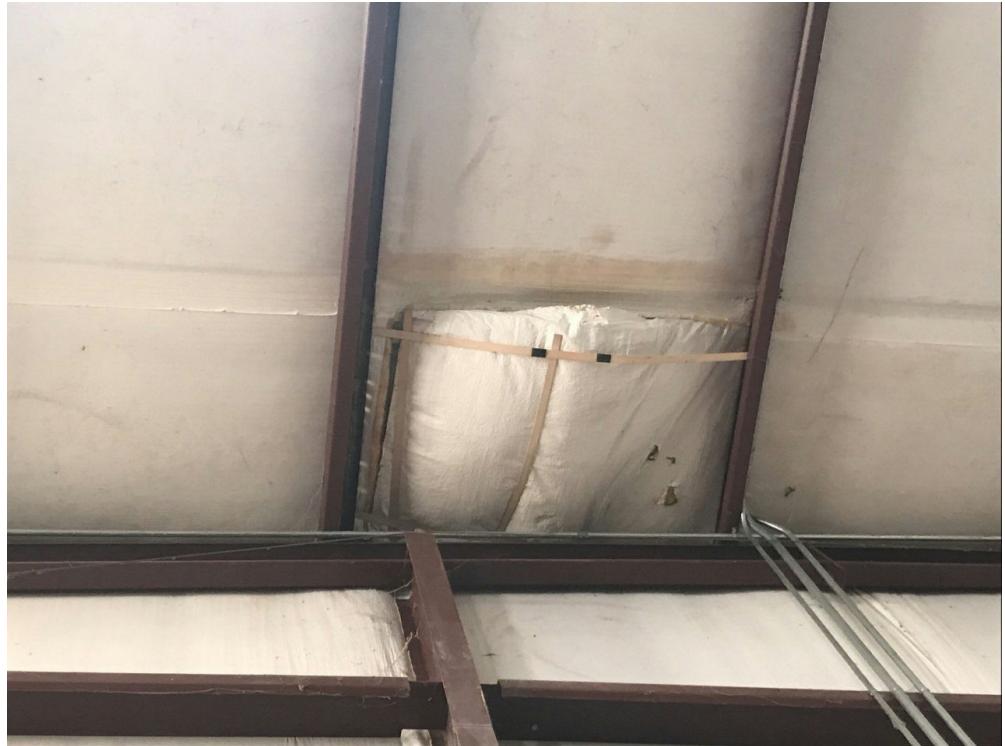
154 154-Roof Insulation

Temporary repairs have been made to patch up and prop up the water damaged insulation from falling onto the employees and the factory equipment. There is a good chance that the metal support beams have rusted. Further evaluation would be required to see if the water damaged insulation has also caused rust.
